PHOTOGRAPHIC INTELLIGENCE REPORT

VITAL RECORDS COPY
STATUS OF NORTH VIETNAMESE RAILROADS

REPORT NO. 21
CIA/PIR 75074

DATE DEC. 1966

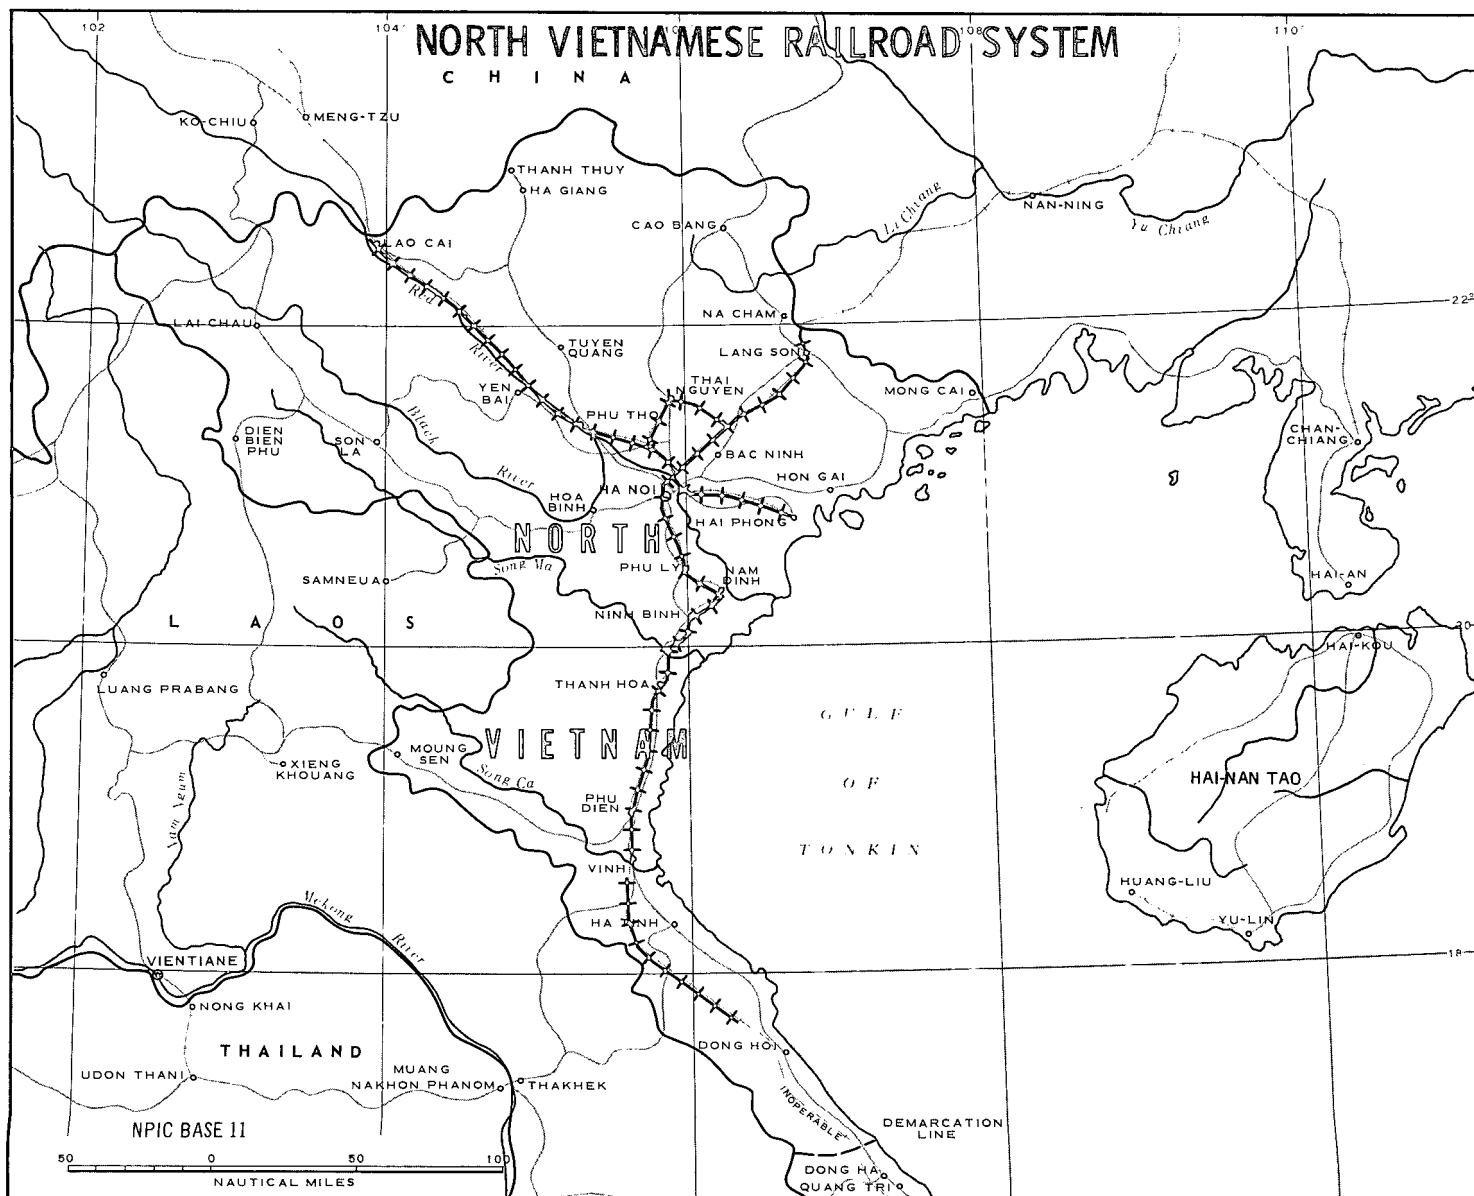
PIR 75074
FIGURE 1 25X1

The railroad system has been broken down into 5 major lines: the Hanoi/Lao Cai Line, the Hanoi/Dong Dang Line, the Hanoi/Haiphong Line, the Hanoi/Dong Hoi Line and the Thai Nguyen Line (Figure I). Annotated maps and photos are used to show the status of each line.

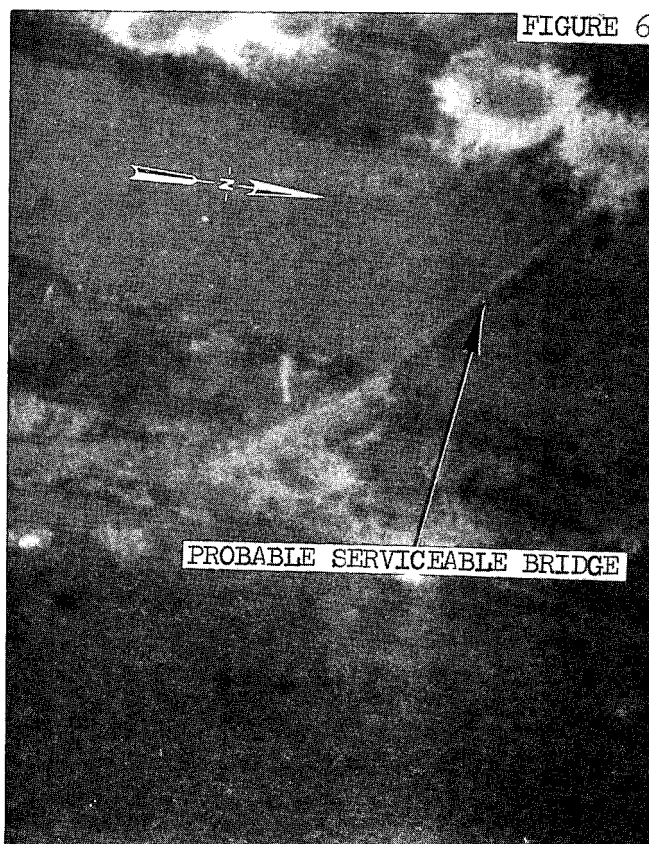
ITEM OF INTEREST NO. 1: Hanoi/Dong Hoi Rail Line

NAME : Qui Vinh RR. Bridge No. 2

The multi-span trestle-type Qui Vinh Railroad Bridge No. 2 has been repaired and is probably serviceable. This is a by-pass for the unserviceable main bridge

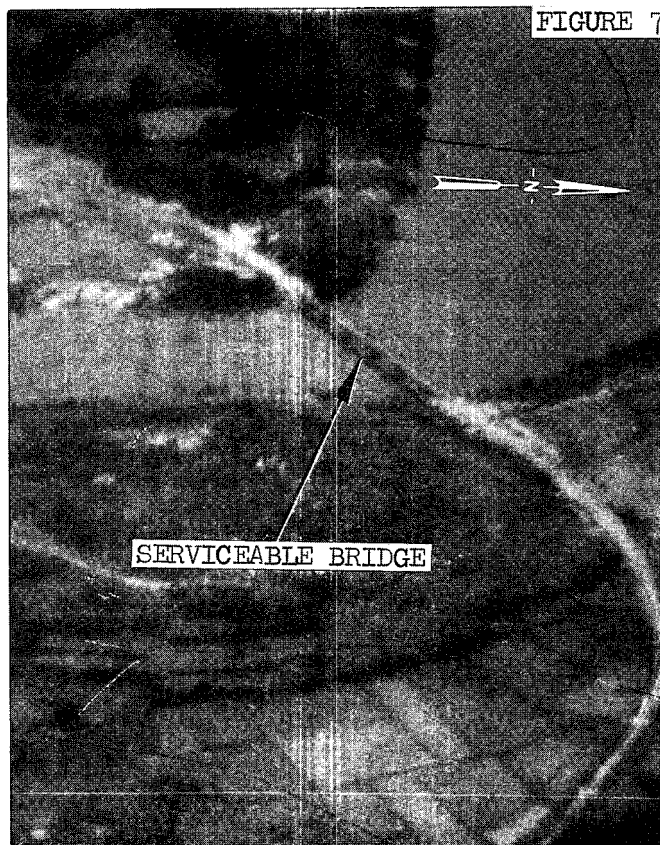
ITEM OF INTEREST NO. 1 CONT.: Hanoi/Dong Hoi Rail Line

NAME : Qui Vinh RR Br. No. 4

The 6 span, deck-beam Qui Vinh Railroad Bridge No. 4 has been completed and is serviceable. There are presently 2 serviceable by-pass bridges at this river crossing. The main bridge and 1 other by-pass are unserviceable.
